So, You Want to Continue to Use Stock Abutments because they are Cheap? They Cause Expensive Preventable Complications

Emil LA Svoboda PhD, DDS

August 12, 2019

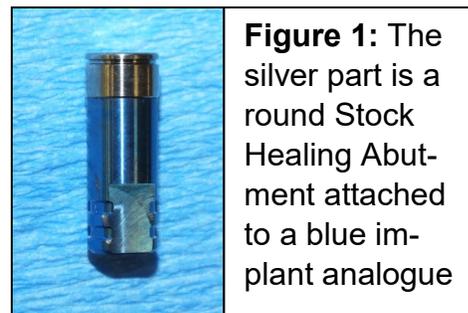
Figure 1: The silver part is a round Stock Healing Abutment attached to a blue implant analogue

Not long ago the SHA was called the coverscrew, and it was usually round and available in a limited number of heights and widths. They were used to provide the dentist with access to the top of the implant without a second stage surgery. The **SHA** also shaped the tissues in the peri-abutment environment. **(Figure 1&2)** The prosthesis that would be anchored to these abutments would often be larger and have a more complex shape than the **SHA**.

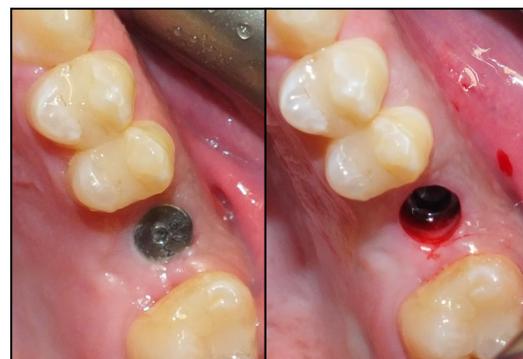
Figure 2: The images show the round Stock Healing Abutment in place and then the top of the implant after it has been removed.

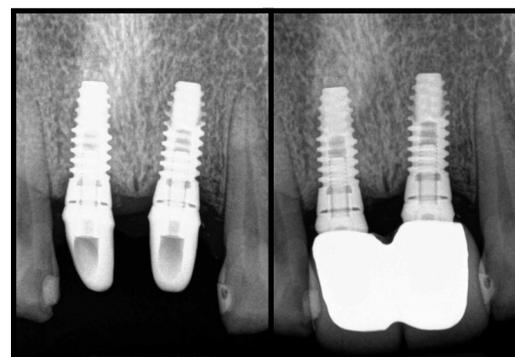
Figure 4: X-ray images with modified stock abutments and their retained crowns with wide open margins.

the height of the abutment can be reduced, its angle can be somewhat modified to allow for a better path of insertion for the prosthesis. Their margins can be somewhat lowered. **(8)** **Figure 4** shows such abutment modifications and wide open-margins after prosthesis installation.

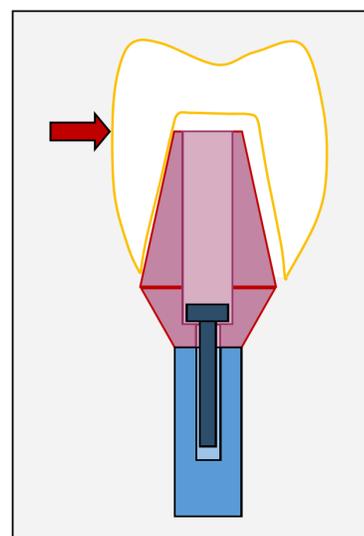
Figure 5: Red arrow represents a tight contact that shoves the crown laterally and exacerbates crown fit problems.

What about the installation of a crown onto its simple Stock Abutment (SA)? Here is where the dentist is likely to face their biggest challenges. It is unlikely that a SA will have an optimal margin position, margin design and emergence profile to facilitate the safe installation of the crown. This SA limitation will make it difficult to prevent the occurrence of residual subgingival cement due to the **GE** or prevent the occurrence of open margins due to **RTD** of the peri-crown tissues. **(Figure 5)**

crown laterally, then the crown margin may get hung up on an incline planes of the abutment. This will likely cause an **underextended margin on one side of the retainer and an overhanging margin on the opposite side**. Whenever there is an open margin, there is likely to be a **hyperocclusion** as the crown is in a lifted state. (Figure 5)

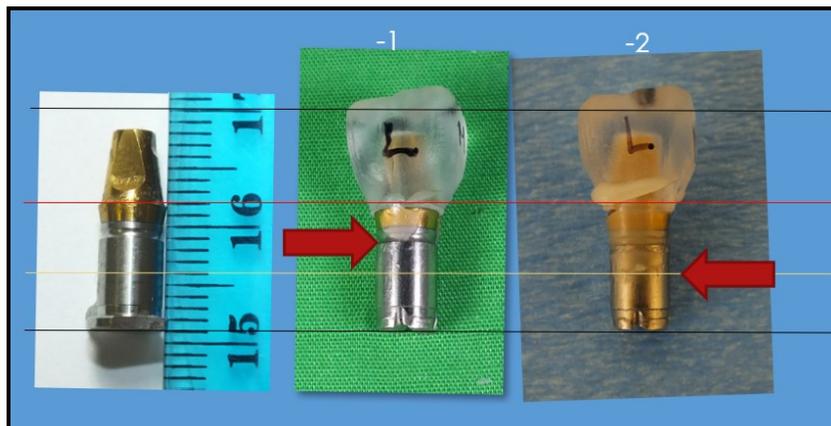
Figure 6: The red arrows designate the extent of excess cement below the gingiva with an abutment margin 1 mm or 2 mm subgingival before crown cementation. The silver part below the abutment is the implant analogue.

Using an in vitro model and cementing a crown with a 1 mm subgingival margin resulted the cement going an average distance of 4.5 mm into the subgingival environment. With a 2 mm subgingival margin, the excess cement was injected an average of 6.3 mm subgingivally. **(Figure 6)** In addition, 100% of these tests resulted in open margins. That experiment demonstrated both the **GE** and how the gingival **Resistance to Displacement (RTD)** could cause subgingival cement and open margins. **A similar experiment in vivo** demonstrated the occurrence of both these complications. Residual subgingival cement and open margins are common complications of cemented prosthetics. **(Figures 7 & 8)** **(7)**

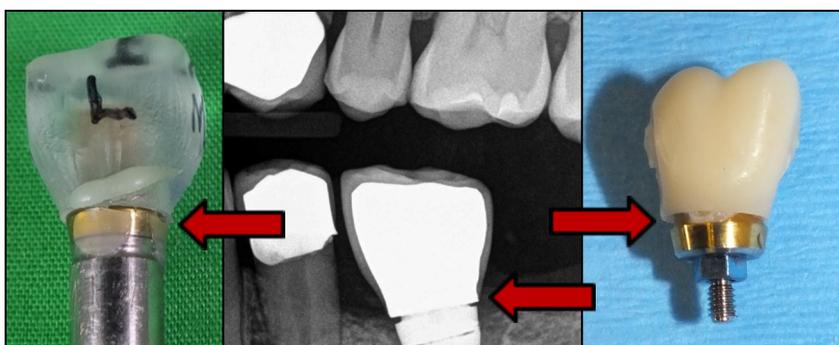
Figure 7: Red arrows show open margins in experiment, x-ray image and removed abutment-crown complex.

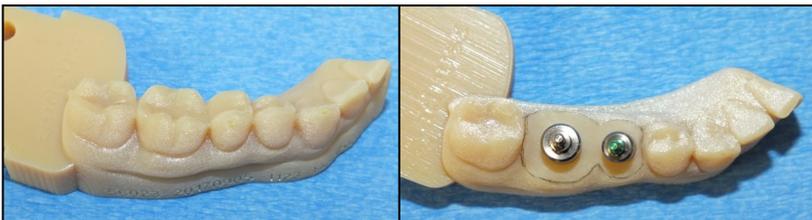
Figure 8: The lower printed model shows the outline of a molar and an adjacent premolar that have been ground down to the tissue level. There is a 5.7 mm and 4.5 mm diameter stock healing abutment positioned in the center of each tooth respectively. Note the large size discrepancy.

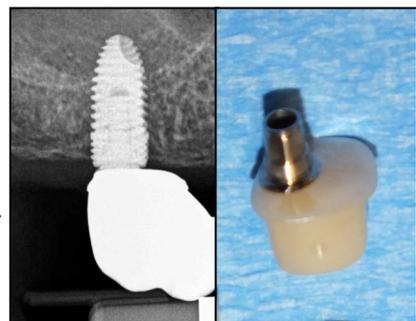
Figure 9: Show the flat profile of the tissue facing surface of a hybrid custom abutment.

Crushing gingival tissues can cause the patient post-installation pain until the crushed tissues are able to heal themselves. **(Figure 9)** A similar problem can occur when trying to seat a pontic into place. These **TE** can keep prosthetic parts from seating properly.

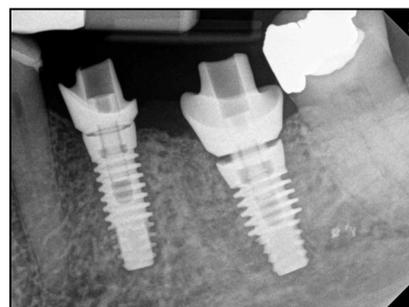
Figure 10: Shows an implant-abutment misfit during installation of a wide profile custom abutment. The adjacent bone was adjusted to allow proper seating.

Bone, adjacent teeth or their replacements also need to be considered. They are usually very resistant to displacement and often need to be adjusted to allow for the proper seating of an abutment and/or prosthesis. **(Figure 10)**

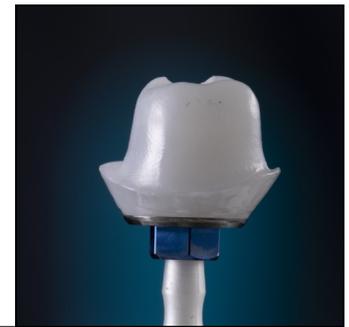
Figure 13: A zirconia shape is attached to an internal hex titanium base propped up by a piece of white plastic.

The WDCA needs to push the gingiva out of the way of the crown to prevent the TE from impeding the seating of the crown and to prevent the GE from causing submarginal cement. In addition, this **WDCA** has an upwards facing margin that directs excess cement out of the tissue spaces, unlike the common tissue facing margins that direct excess cement into the tissue spaces. The **Reverse Margin Abutment (RMA)** is a **WDCA**. (Figures 13&14)

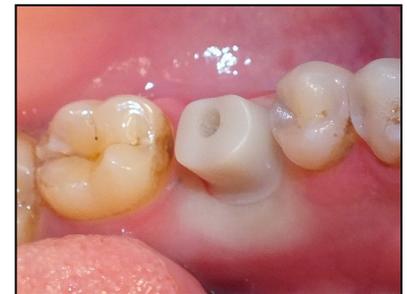
Figure 14: A zirconia hybrid abutment in place. Note how the abutment margin pushes the gingiva away from the space that will be occupied by the crown.

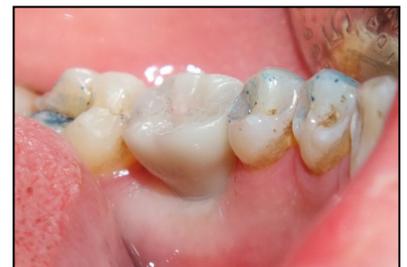
Figure 15: A zirconia crown cemented into place onto its hybrid zirconia retainer.

The RMA cannot do it alone. It works together with a Well-Designed Crown such as the Reverse Margin Crown (RMC). Its shape compliments the design of the **RMA** and includes an external vent constriction in the subgingival environment. This constriction facilitates the flow of excess cement out of the tissue space, unimpeded by contact between the crown and adjacent gingiva. One can say that this shape makes the crown sensitive to and thus prevents the negative **TE** in the peri-abutment/peri-coronal space. This is a big advantage of the **RMA/RMC** combination. (Figure 15&16)

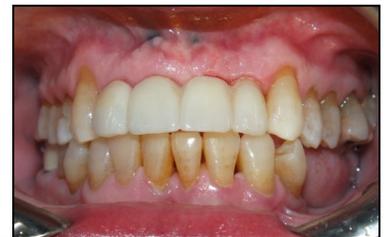
Figure 19: Installation mechanically and biologically safer than ever.

If you don't like the edge of the abutment margin, just shave it off after crown installation. Your hypothetical problem is solved. However, this margin does not seem to have posed problems for my patients. (Figure 19)

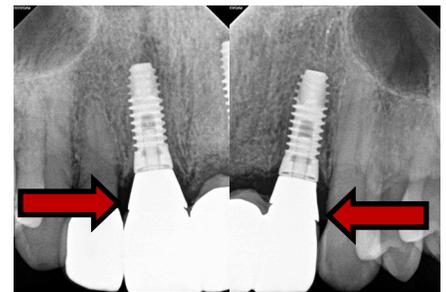
Figure 20: Inflected abutment margins visible on x-ray images (red arrows).

Do you think my patient cares that the RMA appears to be different from conventional margins on an x-ray image? What do you think is more important for my patient? (Figures 20&21) The unique appearance of the **RMA** on the x-ray image or proof of a well-designed restoration that makes her treatment better. Indeed, the unique appearance of the **RMA** on an x-ray image of your treatment shows that you too strive to provide the best treatment possible for your patient.

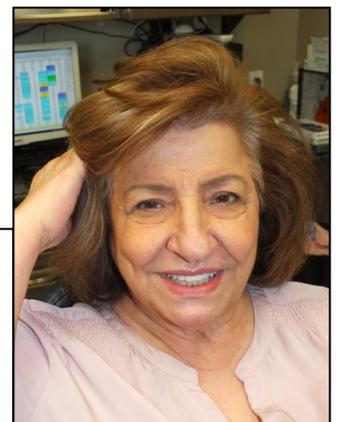
Figure 21: Patient restored with system designed to prevent complications.
